3 Volt Intel StrataFlash[®] Memory

28F128J3A, 28F640J3A, 28F320J3A

Specification Update

August 2001

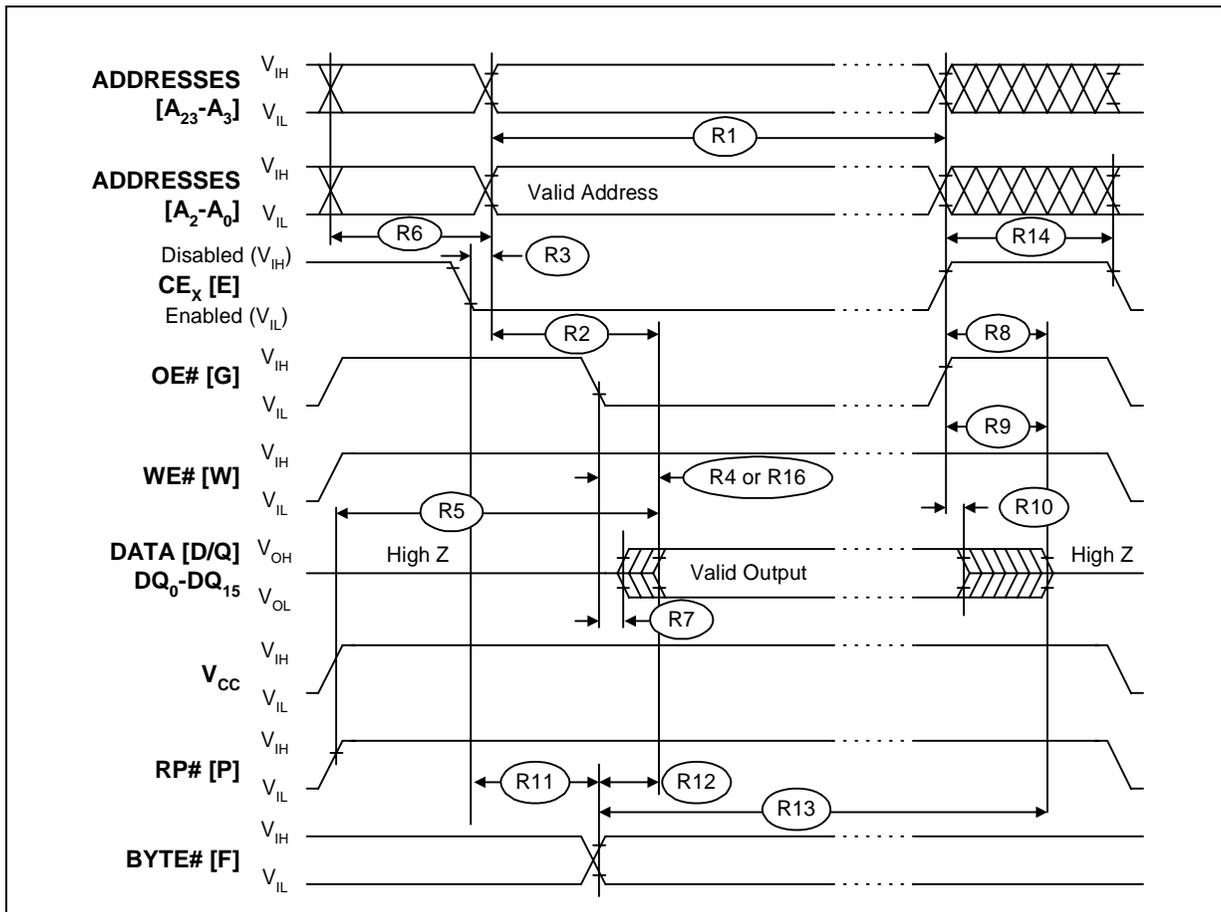
Figure 1. AC Waveform for Standard Word/Byte Read Operations

Problem: Devices need the parameter $t_{ELQX} = 150$ ns minimum. CE low to output in low Z (t_{ELQX}) is designated as R6 in Figure 1, in this Specification Update revision.

Implication: Higher volume prototype testing could experience read failures if this erratum is ignored.

Problem: Devices need the parameter $t_{ELAV} = 500$ ns maximum. Chip Enable to Address Valid (t_{ELAV}) is designated as R3 in Figure 1, in this Specification Update revision.

Workaround: Use devices for initial lower volume prototype development.
