PIC16F/LF1824/1828 Family

Silicon Errata and Data Sheet Clarification

The PIC16F/LF1824/1828 family devices that you have received conform functionally to the current Device Data Sheet (DS41419A), except for the anomalies described in this document.

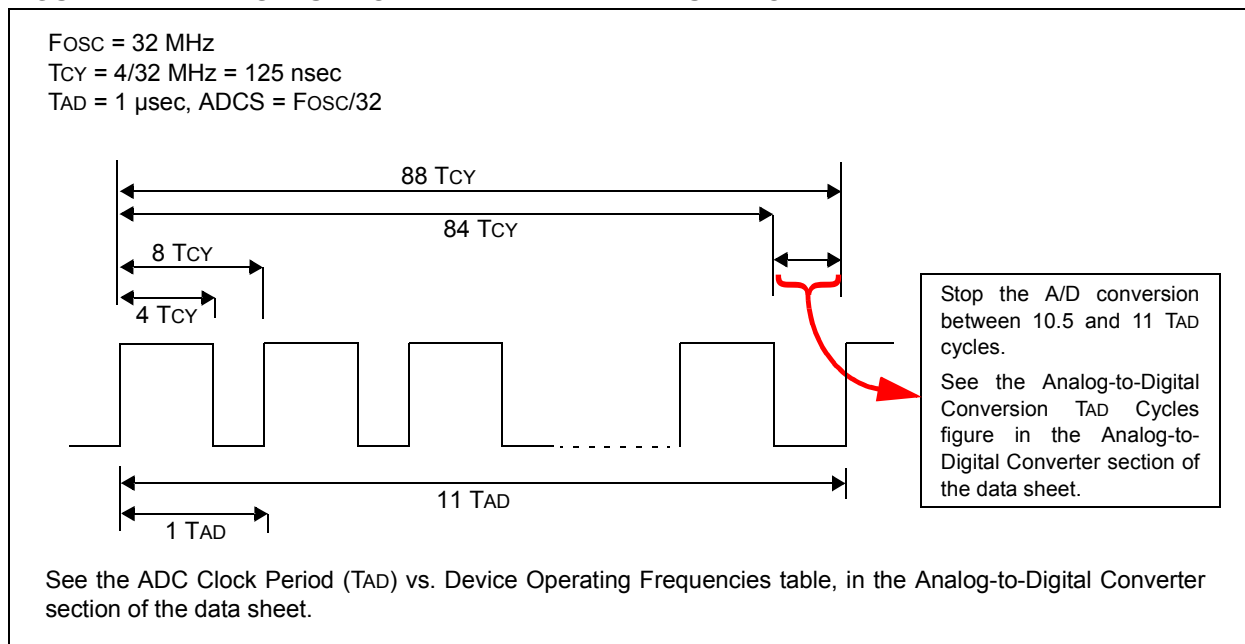
FIGURE 1: INSTRUCTION CYCLE DELAY CALCULATION EXAMPLE

An ADC conversion may not complete under these conditions:

1. When Fosc is greater than 8 MHz and it is the clock source used for the ADC converter.
2. The ADC is operating from its dedicated internal FRC oscillator and the device is not in Sleep mode (any Fosc frequency).

When this occurs, the ADC Interrupt Flag (ADIF) does not get set, the GO/DONE bit does not get cleared, and the conversion result does not get loaded into the ADRESH and ADRESL result registers.

In Figure 1, 88 instruction cycles (Tcy) will be required to complete the full conversion. Each TAD cycle consists of 8 Tcy periods. A fixed delay is provided to stop the A/D conversion after 86 instruction cycles and terminate the conversion at the correct time as shown in the figure above.

Method 3: This method is provided if the application cannot use Sleep mode and requires continuous operation at frequencies above 8 MHz. This method requires early termination of an ADC conversion. Provide a fixed time delay in software to stop the A-to-D conversion manually, after all 10 bits are converted, but before the conversion would complete automatically. The conversion is stopped by clearing the GO/DONE bit in software. The GO/DONE bit must be cleared during the last ½ TAD cycle, before the conversion would have completed automatically. Refer to Figure 1 for details.

Note: The exact delay time will depend on the TAD divisor (ADCS) selection. The Tcy counts shown in the timing diagram above apply to this example only. Refer to Table 3 for the required delay counts for other configurations.
